Mystery wreck may be Lt. Bishop's lost P-40 that was shot down December 7th, 1941

By Dave Trojan, Aviation Historian, davidtrojan@earthlink.net

Dec 2014

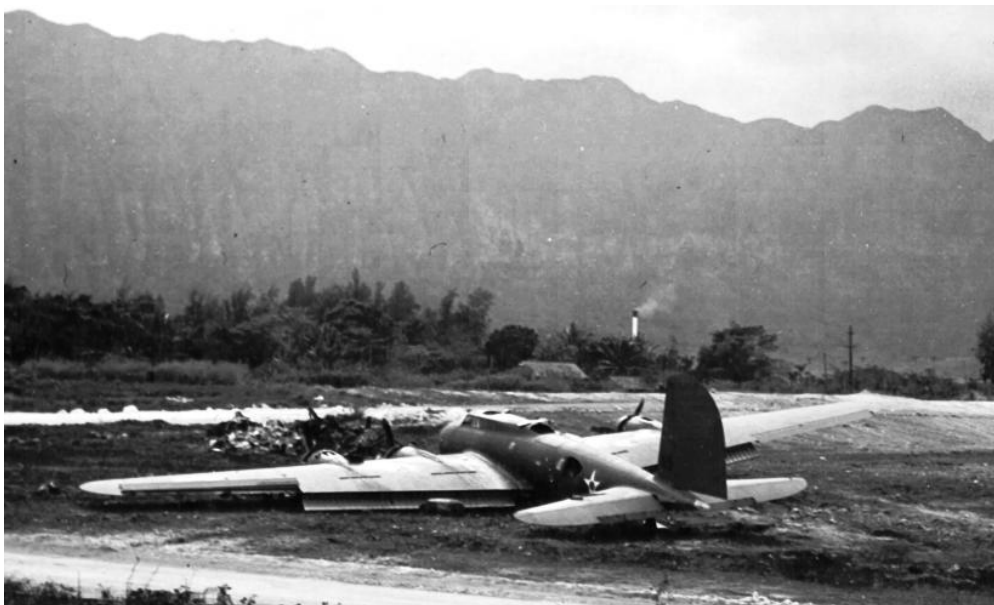
Sergeant Covelesky recalled the event: "No one was aware of the flight of bombers arriving from the states, and to see that approaching monster trailing smoke from its right engines was mind boggling. Our asphalt landing strip at Bellows was hardly long enough to accommodate our P-40s, much less a B-17; and when he made an approach from the ocean downwind, we knew we were in for a breathtaking crash landing. Even though his wheels were down, he flared out and touched down halfway on the strip, knowing he wouldn't be able to stop, retracted the wheels and slid off the runway over a ditch and into a cane field bordering the air strip." The B-17 bomber was repeatedly machine gunned during the second attack. Afterwards they counted at least 73 bullet holes and the bomber was "a complete washout".

Wrecked B-17 at Bellows Field shortly after the attack, USAF Photo

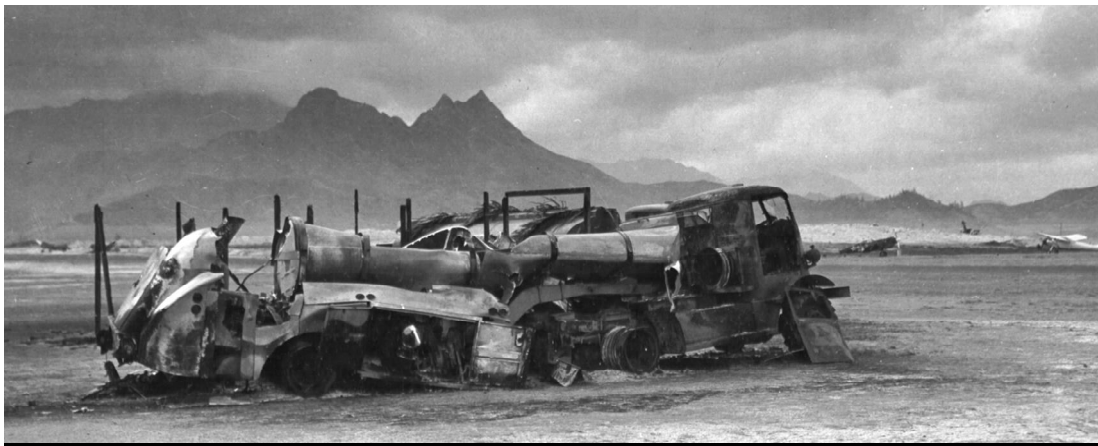
The Japanese strafing attack plastered the field with machine gun bullets. The ensuing bedlam was further compounded by a 2000 gallon 100 octane gasoline truck that was quickly set ablaze and was spewing jets of fire and billowed angry rolling black smoke to darken the sky overhead.

Burned out fuel truck at Bellows Field after the attack, USAF photo

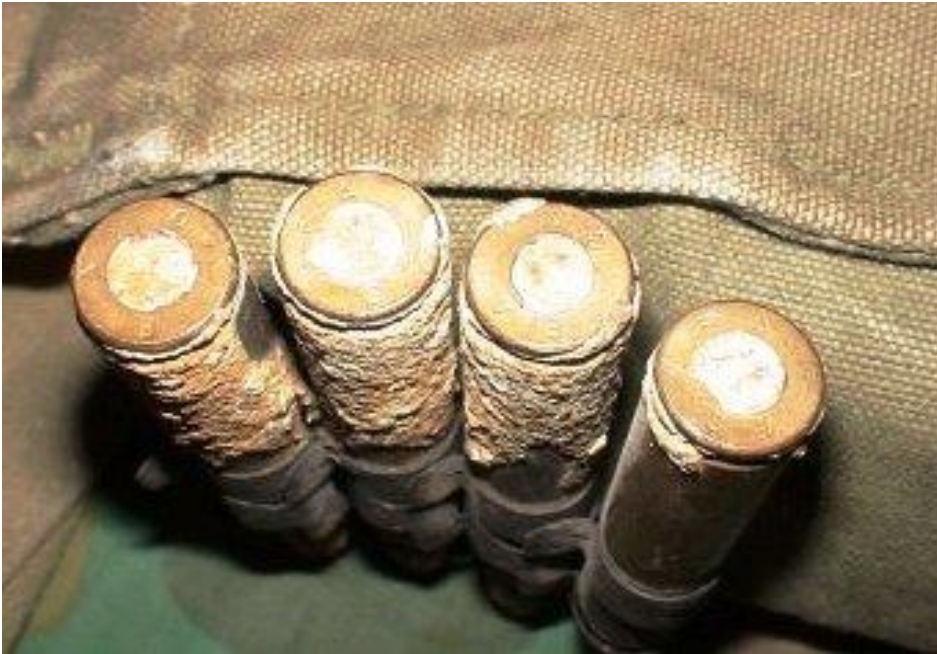
30 cal. Linked Ammunition

Shell cases are stamped F.A. 37 and F.A. 40

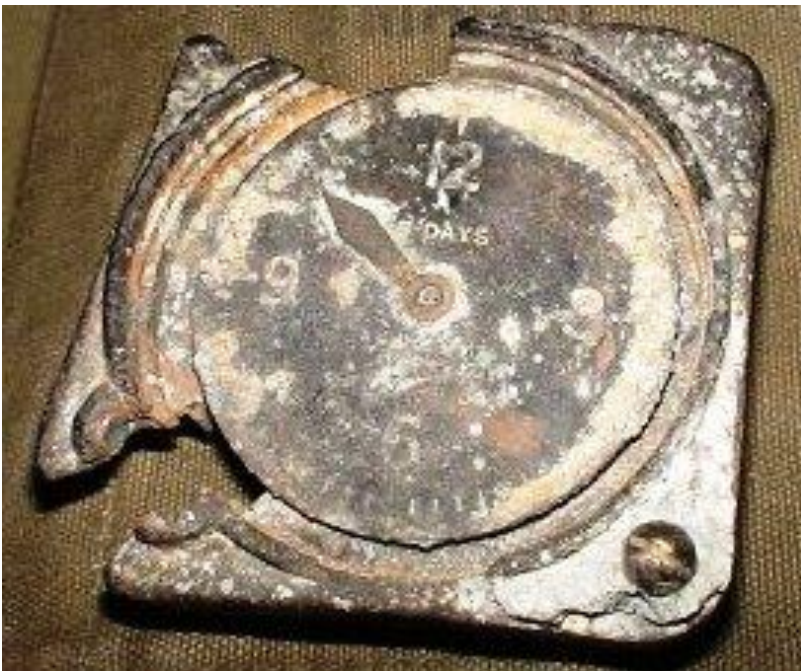
Eight Day Clock

The clock reads approximately 1030-1045. The three planes at Bellows Field attempted to takeoff at about 0900 and were shot down shortly afterwards. This is well before the reading on the clock. The clock may have kept running after the plane crashed or the clock may not have been set to the correct time before the plane took off.

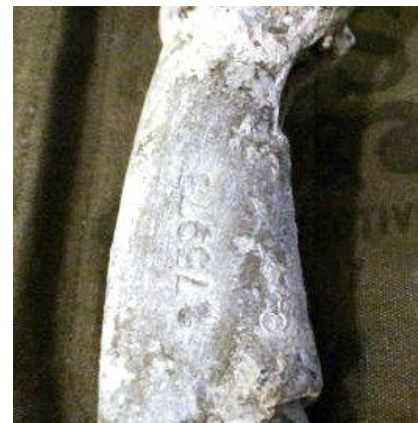
grip close up

Part number on the control stick is 275973.

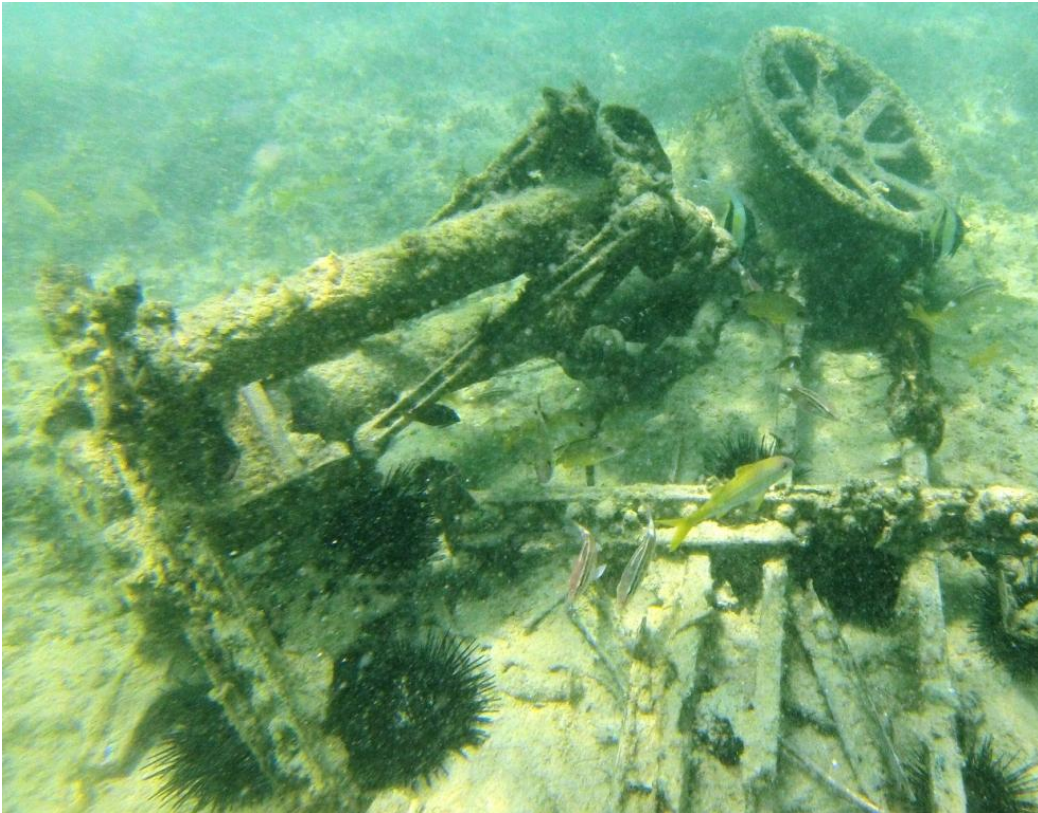
Photo of wreck site showing landing gear provided by Blade Shepherd-Jones

Using the photos provided, the site was positively identified as belonging to a P-40 aircraft. This was based on the landing gear configuration and the inline engine.

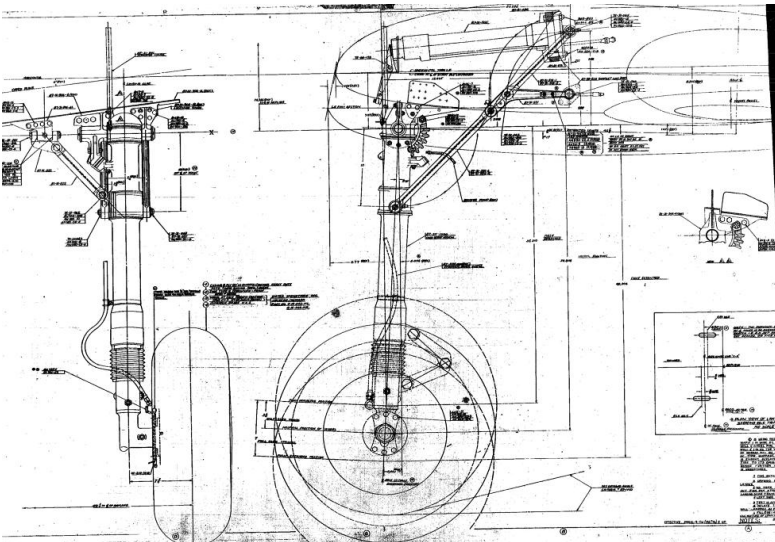
P-40 Landing gear diagram and photo used for comparison
