Mystery wreck may be Lt. Bishop's lost P-40 that was shot down December 7th, 1941

By Dave Trojan, Aviation Historian, davidtrojan@earthlink.net

Dec 2014

Crash site Investigation and historical significance

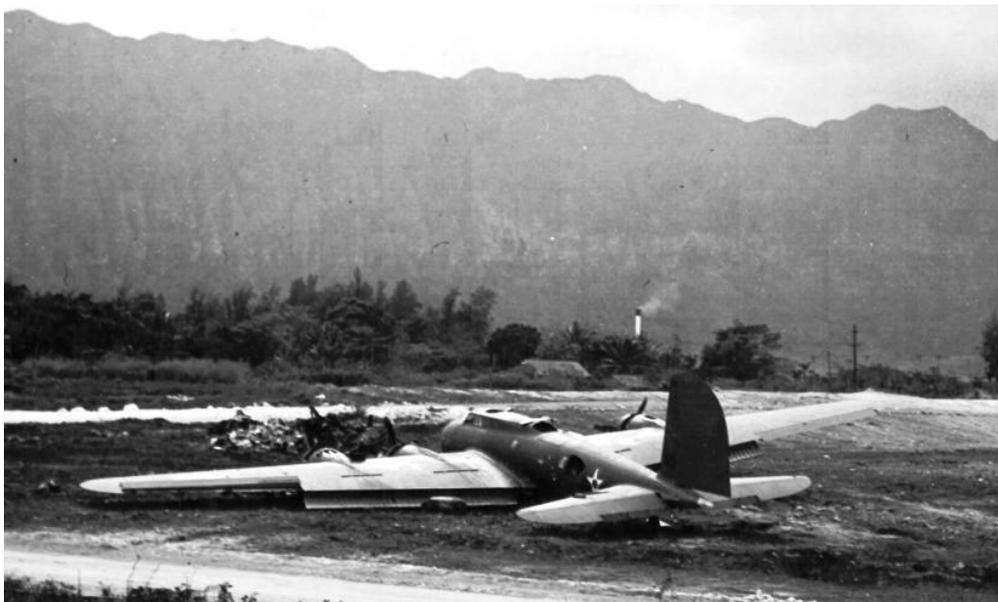
Sergeant Covelesky recalled the event: "No one was aware of the flight of bombers arriving from the states, and to see that approaching monster trailing smoke from its right engines was mind boggling. Our asphalt landing strip at Bellows was hardly long enough to accommodate our P-40s, much less a B-17; and when he made an approach from the ocean downwind, we knew we were in for a breathtaking crash landing. Even though his wheels were down, he flared out and touched down halfway on the strip, knowing he wouldn't be able to stop, retracted the wheels and slid off the runway over a ditch and into a cane field bordering the air strip." The B-17 bomber was repeatedly machine gunned during the second attack. Afterwards they counted at least 73 bullet holes and the bomber was "a complete washout".

Wrecked B-17 at Bellows Field shortly after the attack, USAF Photo

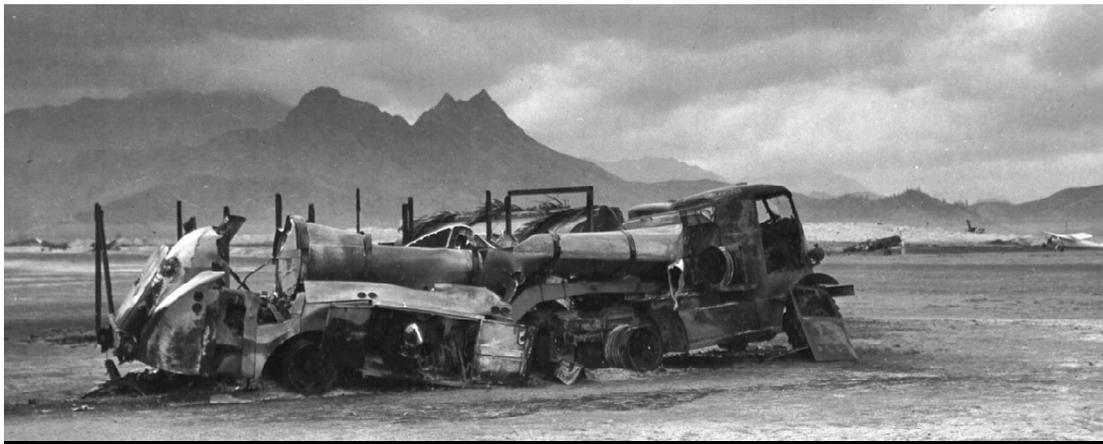
The Japanese strafing attack plastered the field with machine gun bullets. The ensuing bedlam was further compounded by a 2000 gallon 100 octane gasoline truck that was quickly set ablaze and was spewing jets of fire and billowed angry rolling black smoke to darken the sky overhead.

Burned out fuel truck at Bellows Field after the attack, USAF photo

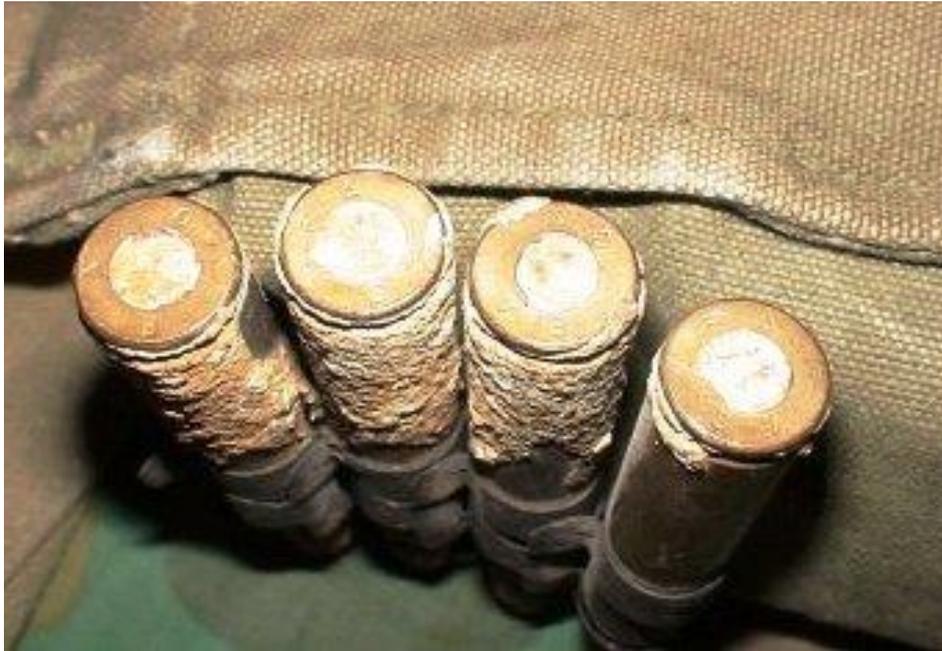
30 cal. Linked Ammunition

Shell cases are stamped F.A. 37 and F.A. 40

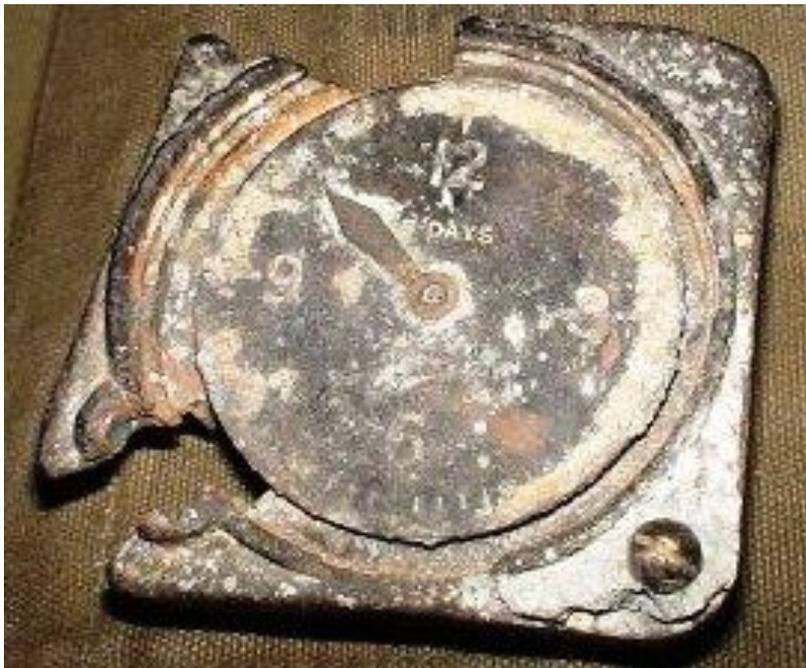
Eight Day Clock

The clock reads approximately 1030-1045. The three planes at Bellows Field attempted to takeoff at about 0900 and were shot down shortly afterwards. This is well before the reading on the clock. The clock may have kept running after the plane crashed or the clock may not have been set to the correct time before the plane took off.

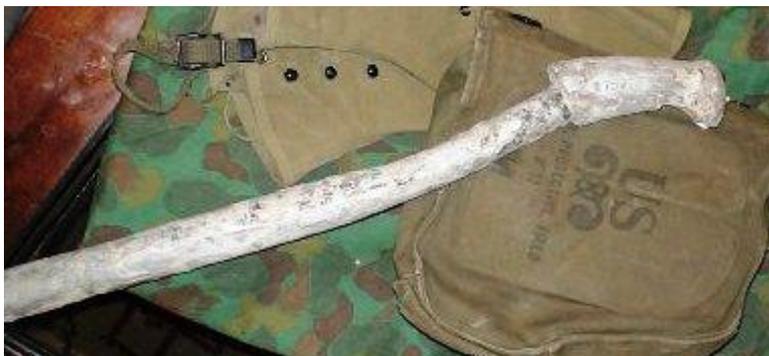
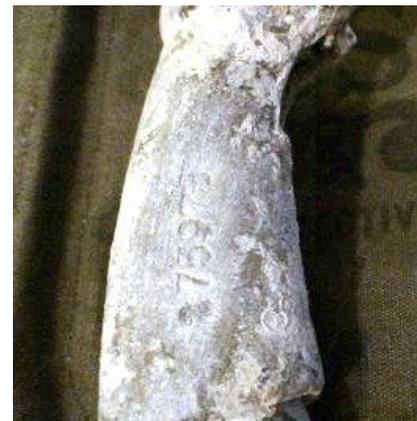
Control stick

Part number on the control stick is 275973.

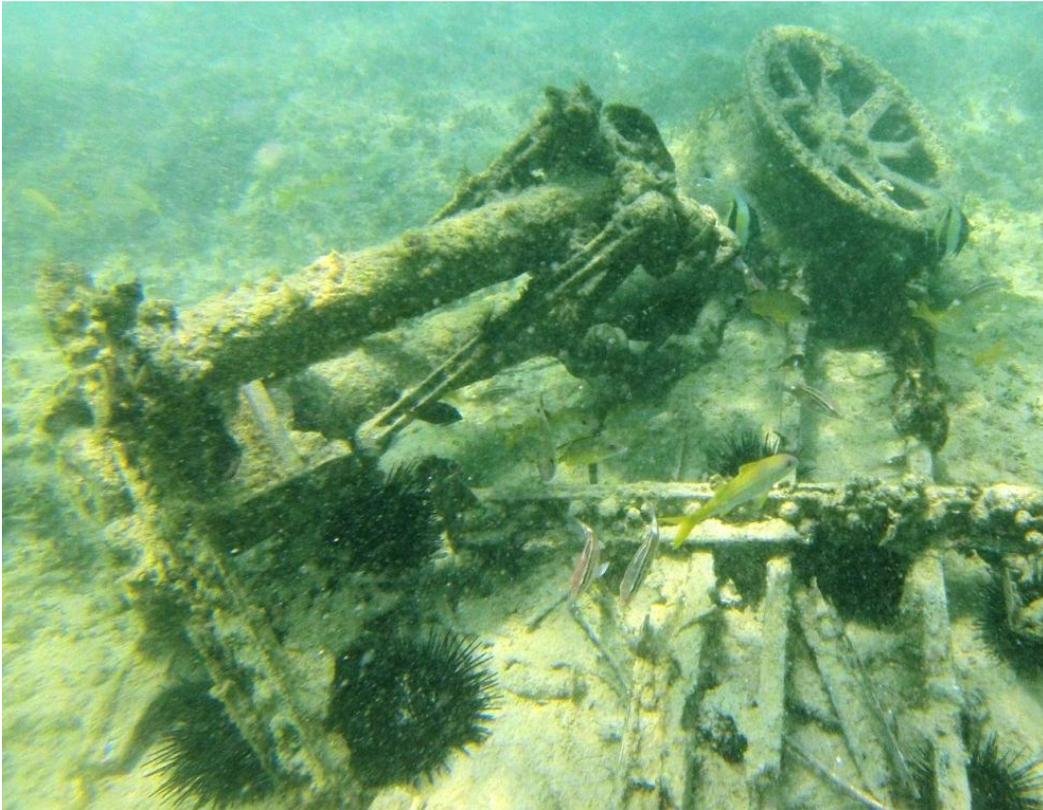
Photo of wreck site showing landing gear provided by Blade Shepherd-Jones

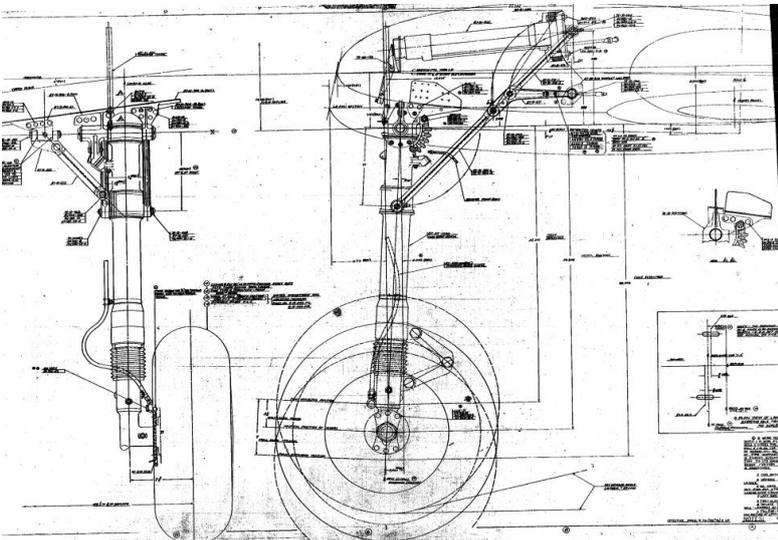
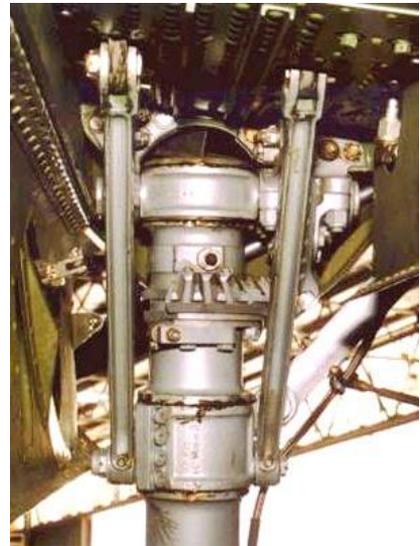
P-40 Landing gear diagram and photo used for comparison

Using the photos provided, the site was positively identified as belonging to a P-40 aircraft. This was based on the landing gear configuration and the inline engine.

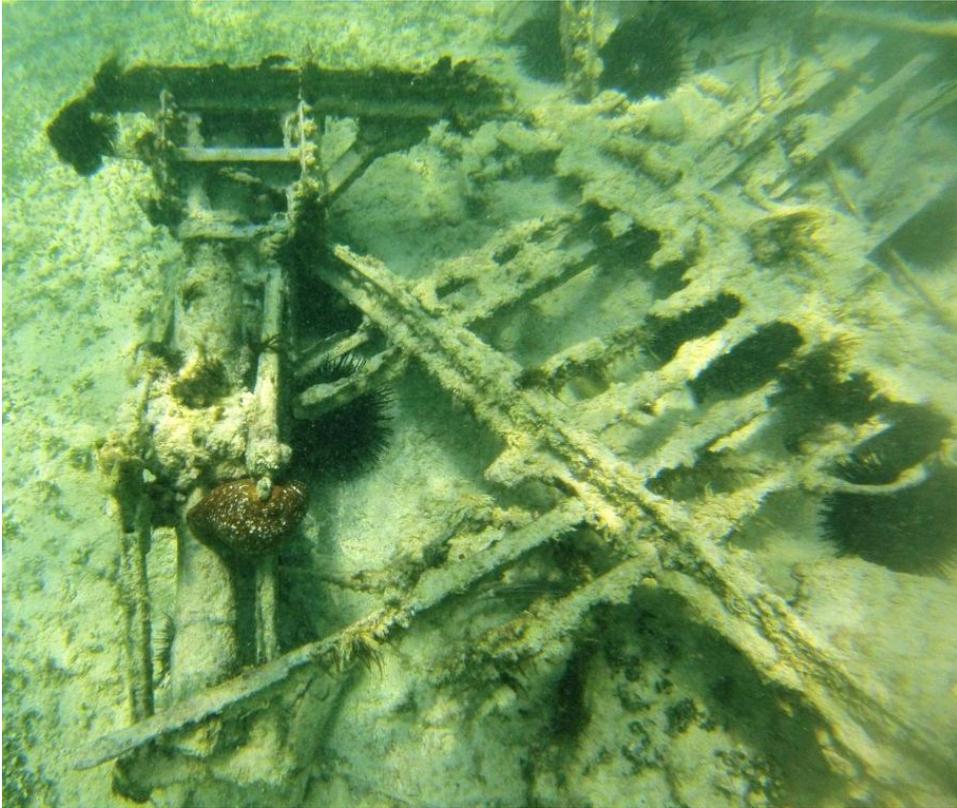
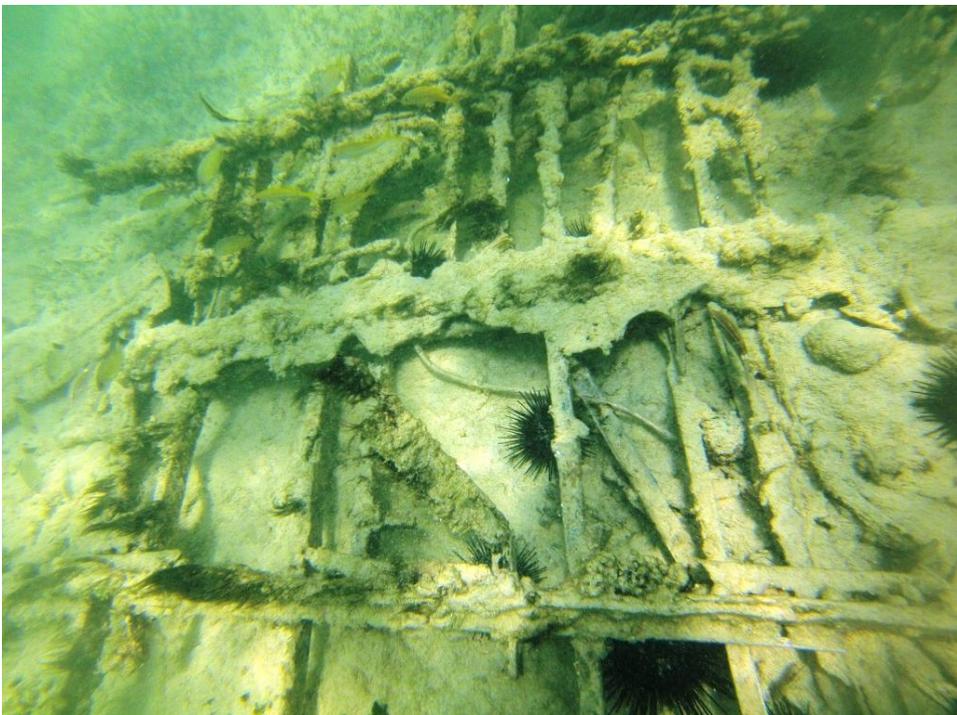
Photos of wreck site provided by Blade Shepherd-Jones

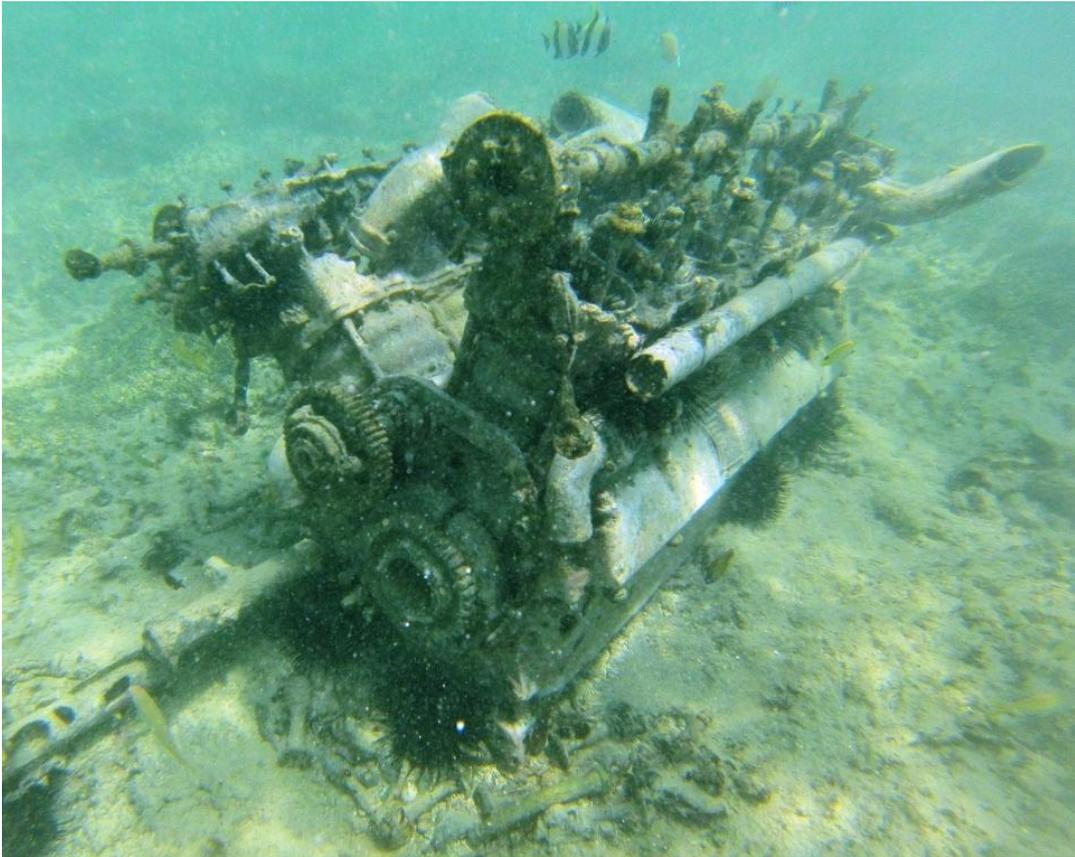
Engine at the wreck site photo by Blade Shepherd-Jones

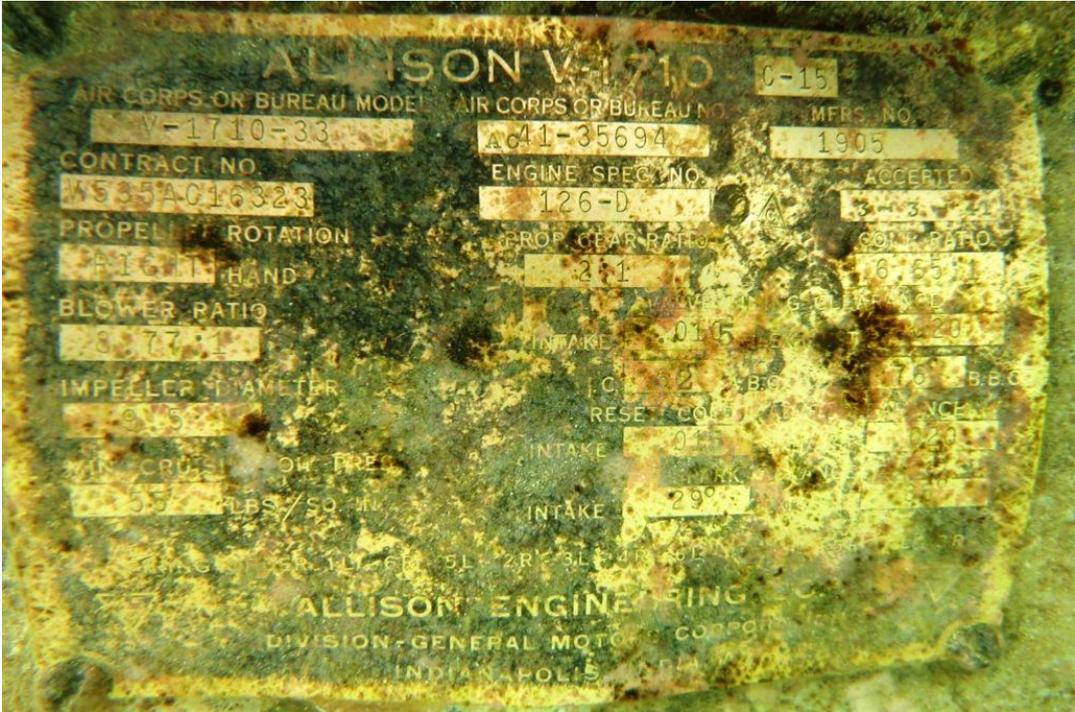
Engine Data Plate photographed underwater by Blade Shepherd-Jones

Allison V-1710-33 C-15, Air Cops or Bureau No, AC 41-35694, MFRS NO 1905, Accepted 3-3-41, contract# W535-AC16323, Engine Spec # 126-D

Note the engine accepted date of 3-3-41 would indicate the aircraft was a P-40B if the engines and airframe were delivered close to each other.

Note according to one source, P-40Cs in the Curtiss construction block of 16104-16296 used the Allison engine order for a V-1710-33 which originally would have been in the 41.35### range as seen on other P40Cs in the same block. This would indicate that the engine was installed on a P-40C.

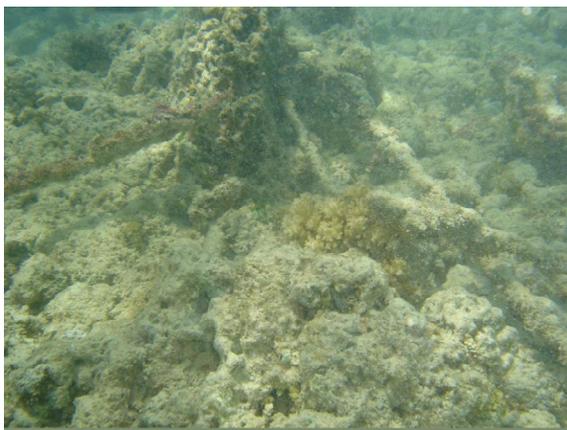
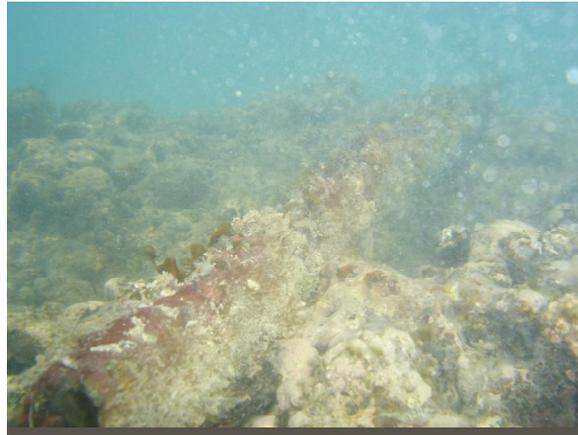
As part of the evidence of the wreckage found off Bellows are two photos that appear to show some kind of coral encrusted manmade objects. Unfortunately, no photo was provided of the wheel, because the discoverer claimed it is the hardest to relocate and he did not have a camera at the time of the other pictures. No artifacts were recovered from this site and it is very difficult to tell what is located underwater using the pictures.

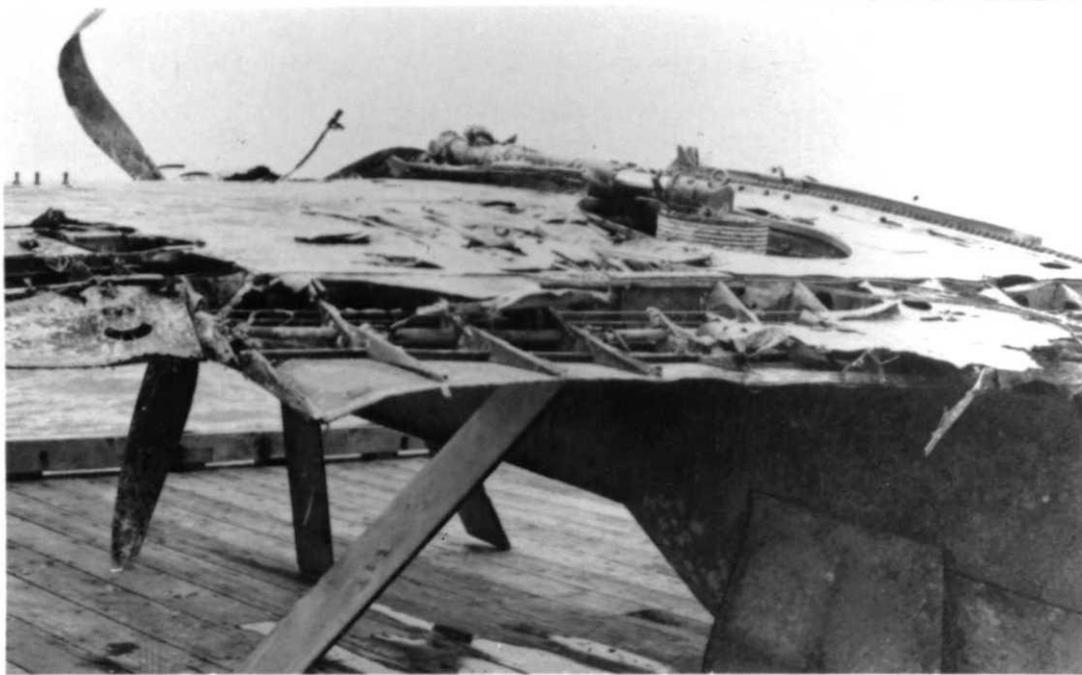
description. However, the eyewitness account by Edward Covelsky when he recalled the events of December 7, 1941 at Bellows Field, stated Bishop's landing gear was disabled by fire from the Japanese aircraft and did not retract, so this is most likely not his plane. There is no official record or other information that the wreck recovered in 1943 was in fact Bishop's P-40. It is most likely a completely different wreck from a later date. The wreck looks to be in too good a condition to have been underwater for nearly two years, but it is hard to tell.

A P-40, shot down on take-off on Dec. 7, is retrieved from the water nearly two years later in September 1943. Col. L.M. Sanders, USAF Ret.
