# Mystery wreck may be Lt. Bishop's lost P-40 that was shot down December 7<sup>th</sup>, 1941

By Dave Trojan, Aviation Historian, [davidtrojan@earthlink.net](mailto:davidtrojan@earthlink.net)

Dec 2014

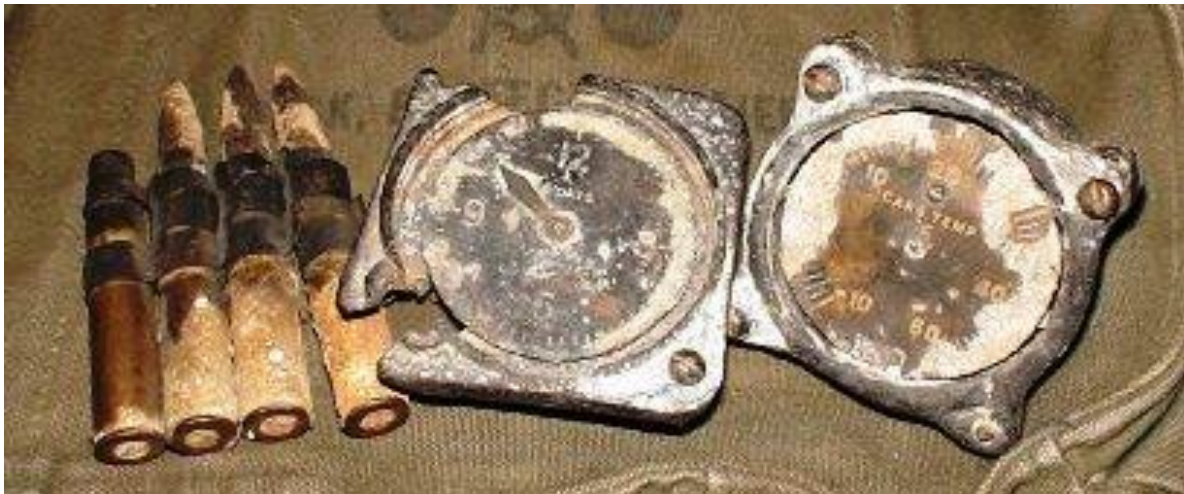
**Group of artifacts recovered from the wreck**

The artifacts recovered in 1977 from the Kailua wreck site are very rare and should be treated appropriately and conserved by professionals. The artifacts could be used to **represent** all the P-40 Warhawks that operated from Bellows Field.

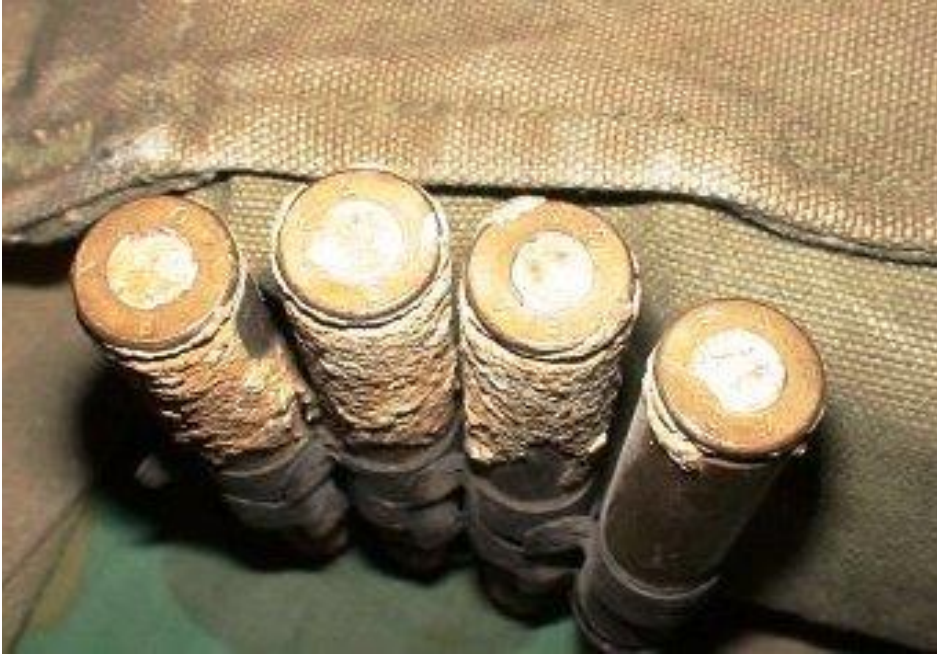
**30 cal. Linked Ammunition**

Shell cases are stamped F.A. 37 and F.A. 40

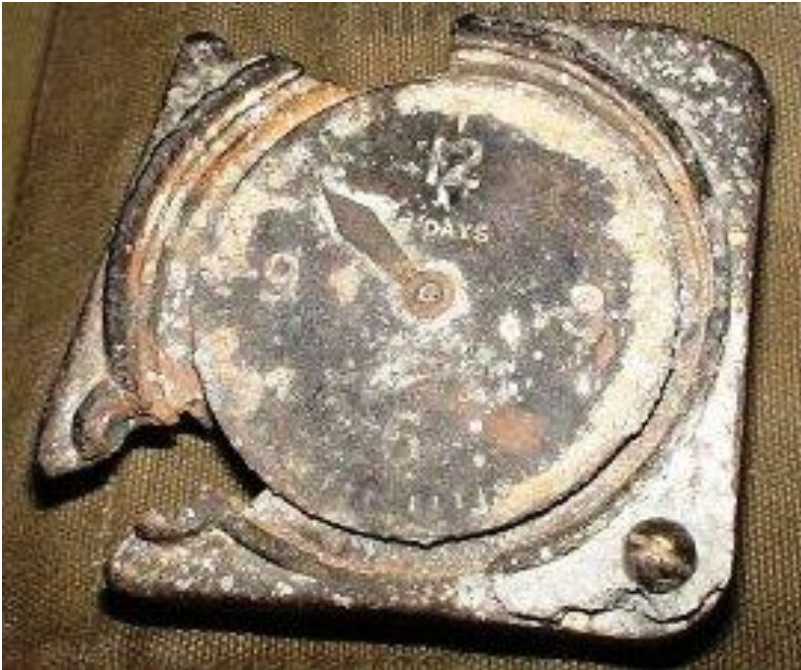
**Eight Day Clock**

The clock reads approximately 1030-1045. The three planes at Bellows Field attempted to takeoff at about 0900 and were shot down shortly afterwards. This is well before the reading on the clock. The clock may have kept running after the plane crashed or the clock may not have been set to the correct time before the plane took off.

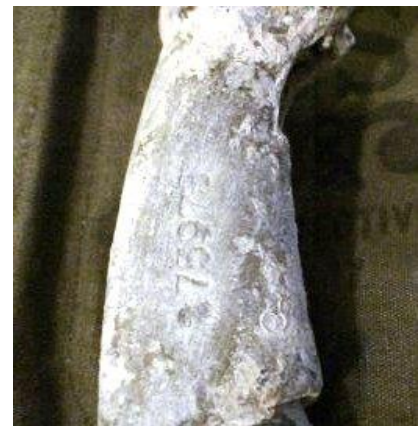
**grip close up**

Part number on the control stick is 275973.

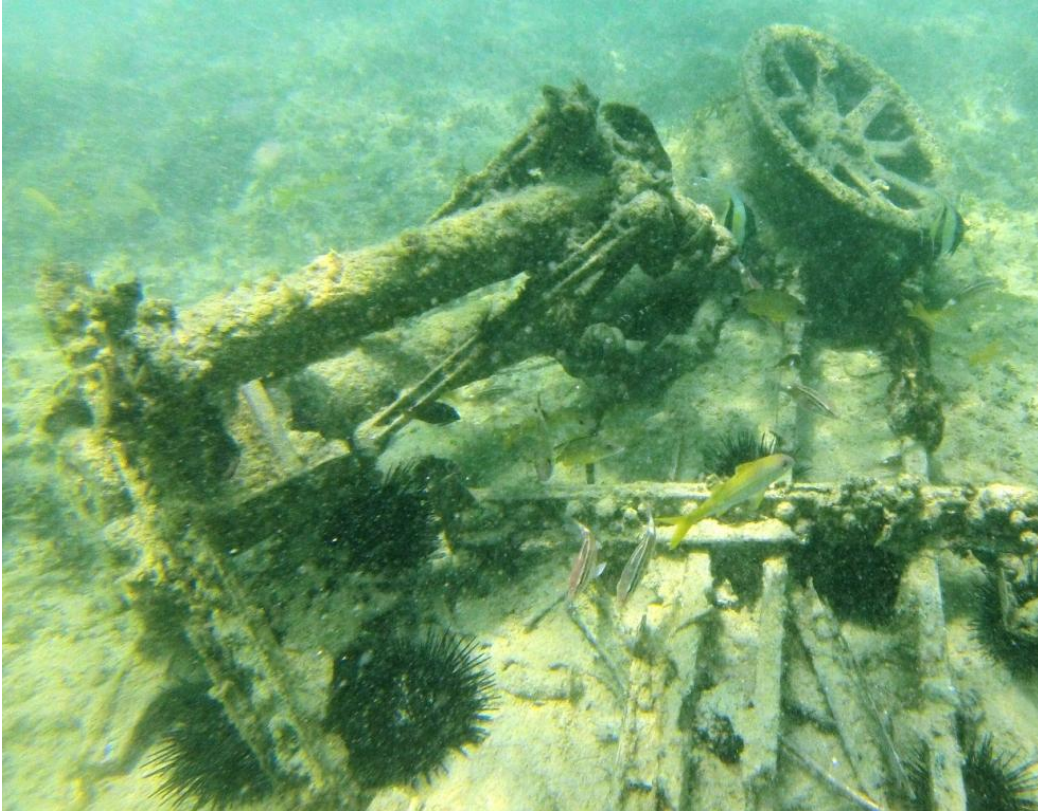
**Photo of wreck site showing landing gear provided by Blade Shepherd-Jones**

Using the photos provided, the site was positively identified as belonging to a P-40 aircraft. This was based on the landing gear configuration and the inline engine.
