Mystery wreck may be Lt. Bishop's lost P-40 that was shot down December 7th, 1941

By Dave Trojan, Aviation Historian, davidtrojan@earthlink.net

Dec 2014

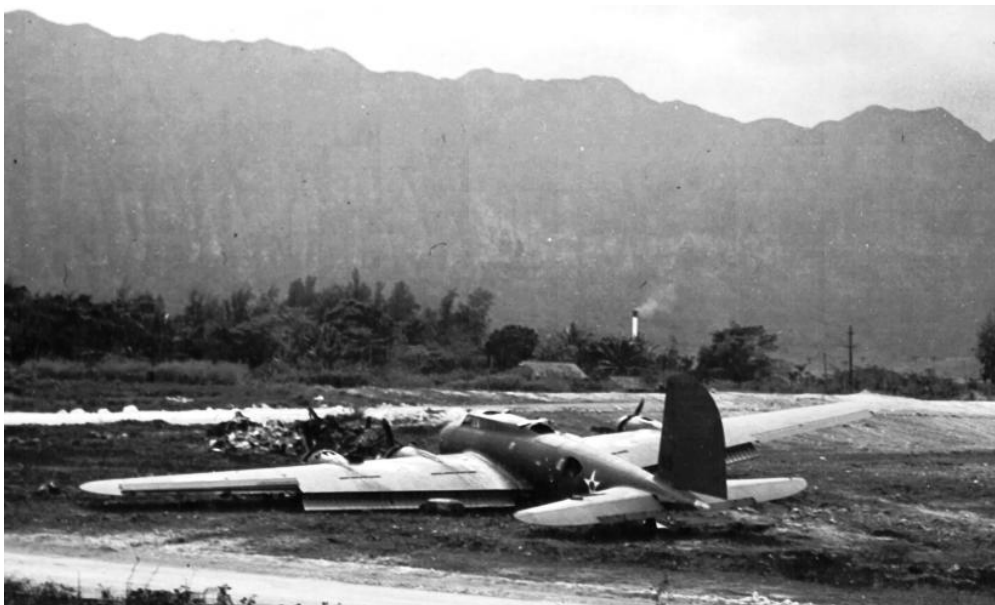
Sergeant Covelesky recalled the event: "No one was aware of the flight of bombers arriving from the states, and to see that approaching monster trailing smoke from its right engines was mind boggling. Our asphalt landing strip at Bellows was hardly long enough to accommodate our P-40s, much less a B-17; and when he made an approach from the ocean downwind, we knew we were in for a breathtaking crash landing. Even though his wheels were down, he flared out and touched down halfway on the strip, knowing he wouldn't be able to stop, retracted the wheels and slid off the runway over a ditch and into a cane field bordering the air strip." The B-17 bomber was repeatedly machine gunned during the second attack. Afterwards they counted at least 73 bullet holes and the bomber was "a complete washout".

Wrecked B-17 at Bellows Field shortly after the attack, USAF Photo

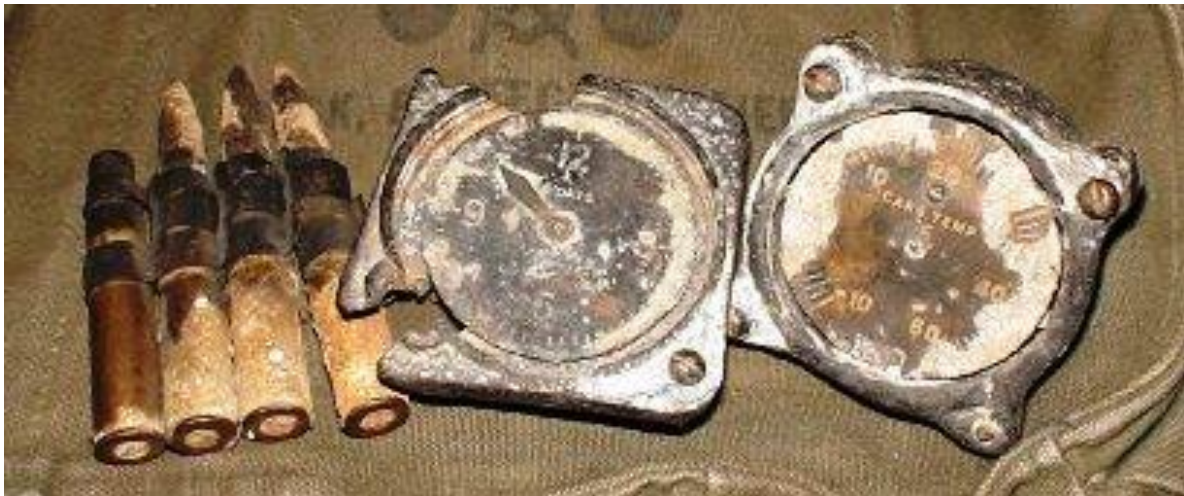
Group of artifacts recovered from the wreck

The artifacts recovered in 1977 from the Kailua wreck site are very rare and should be treated appropriately and conserved by professionals. The artifacts could be used to **represent** all the P-40 Warhawks that operated from Bellows Field.

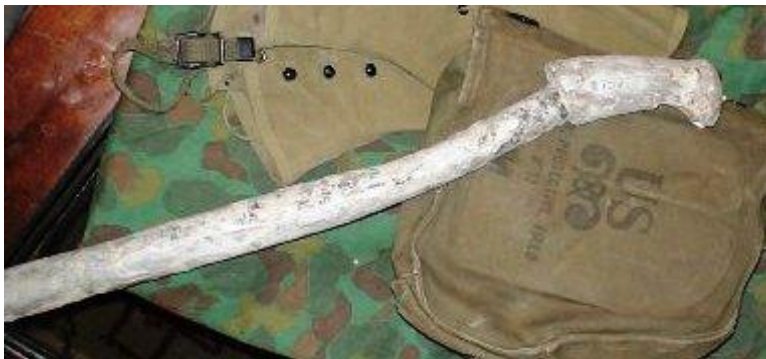
Control stick

grip close up

Part number on the control stick is 275973.
