Mystery wreck may be Lt. Bishop's lost P-40 that was shot down December 7th, 1941

By Dave Trojan, Aviation Historian, davidtrojan@earthlink.net

Dec 2014

Crash site Investigation and historical significance

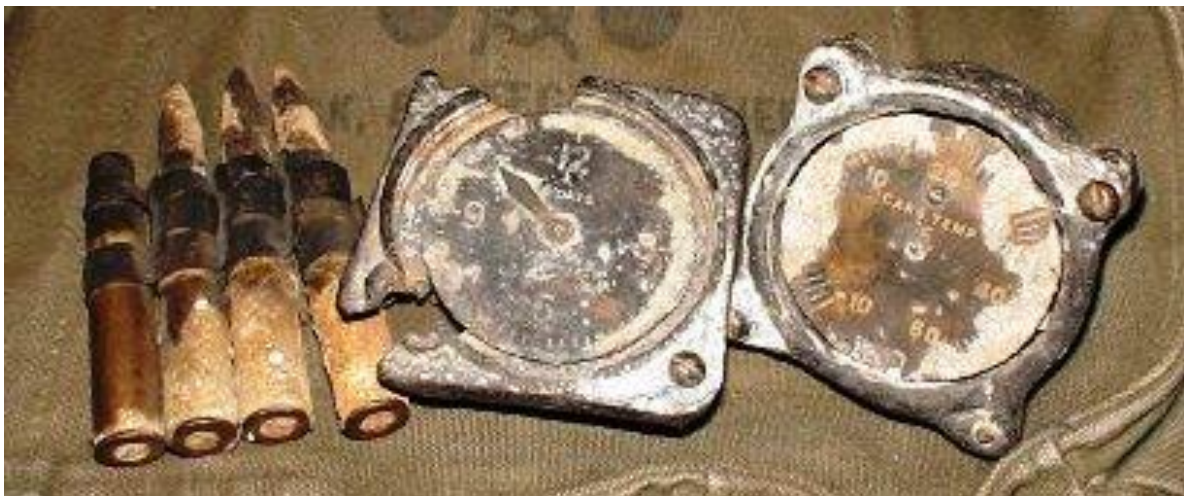
Group of artifacts recovered from the wreck

The artifacts recovered in 1977 from the Kailua wreck site are very rare and should be treated appropriately and conserved by professionals. The artifacts could be used to **represent** all the P-40 Warhawks that operated from Bellows Field.

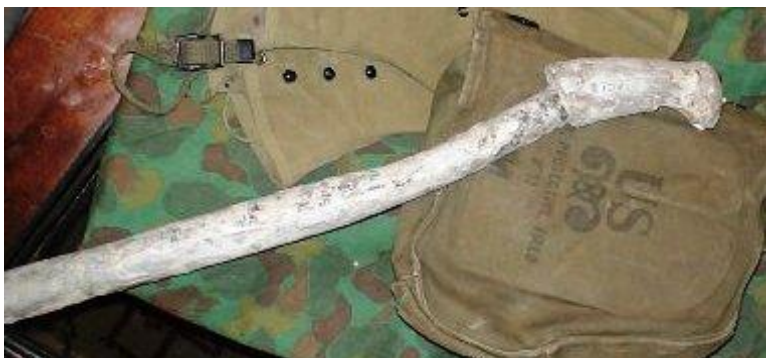
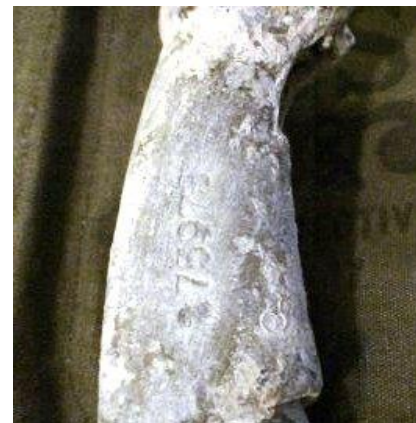
Control stick

grip close up

Part number on the control stick is 275973.

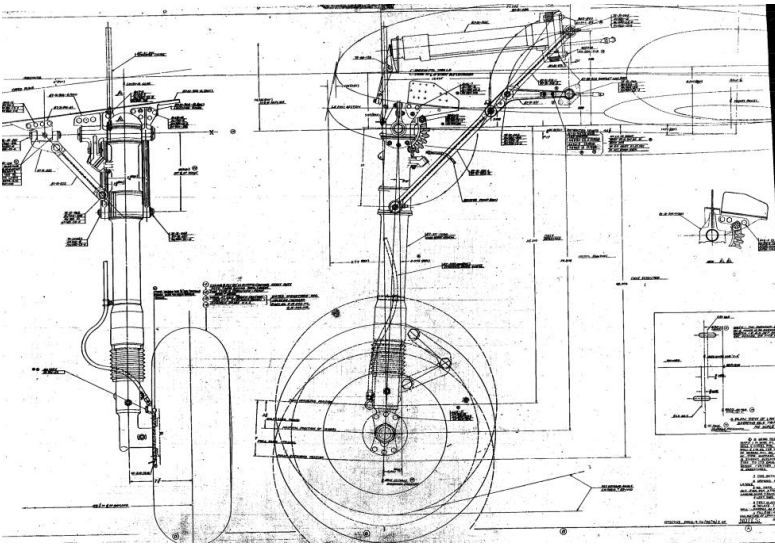
P-40 Landing gear diagram and photo used for comparison

Using the photos provided, the site was positively identified as belonging to a P-40 aircraft. This was based on the landing gear configuration and the inline engine.
