Mystery wreck may be Lt. Bishop's lost P-40 that was shot down December 7th, 1941

By Dave Trojan, Aviation Historian, davidtrojan@earthlink.net

Dec 2014

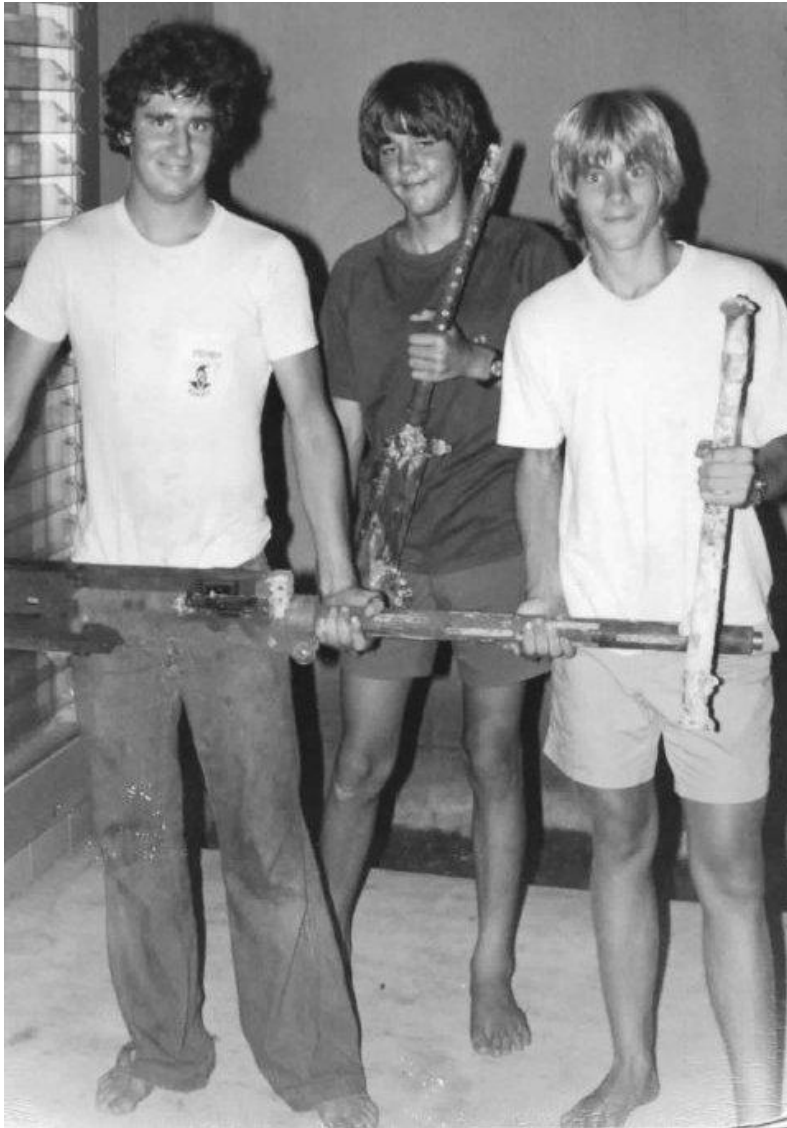
Three proud young boys showing off their treasure

Artifacts recovered by the trio included: carburetor temperature gauge, control stick, eight day clock, part of the artificial horizon indicator, radio equipment, machine guns and some ammunition. An inventory of some of the items and their identity marks was later made by one of the boy's father.

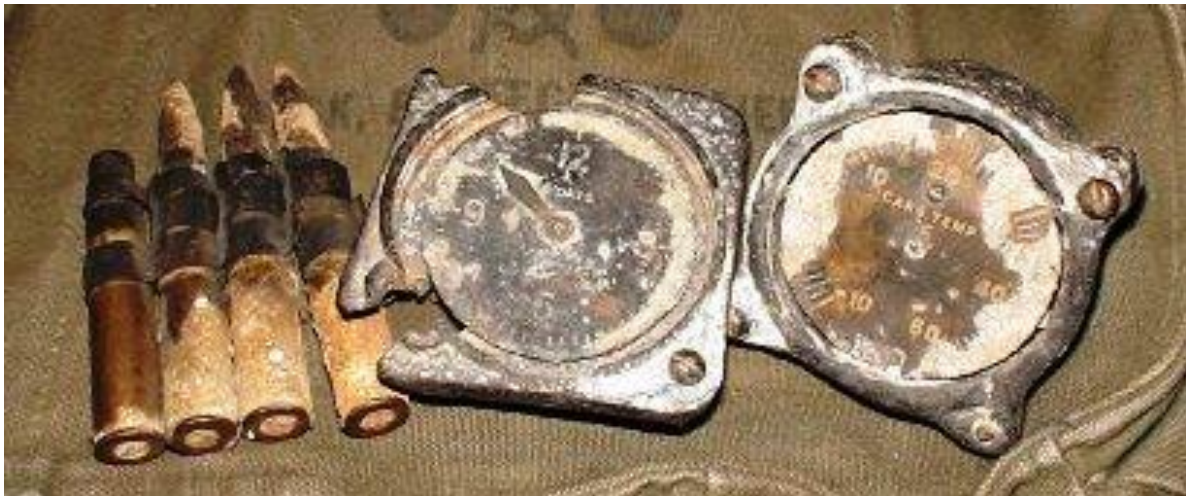
Surviving Artifacts

All these years later, these artifacts have remained hidden away as treasured keepsakes from the adventure so long ago. Over time, one of the boys realized that maybe in some small way he could help bring some closure to a family or just solve another of the many mysteries of military plane crashes from that era. He contacted me in an effort to try and determine which plane these artifacts came from. He was willing to have the items go to a surviving family member or a museum. He wants the artifacts to find a home, where ever that may be, better than a box in his closet. The question is which plane did they come from? Could they have come from Bishops' lost P-40?

Group of artifacts recovered from the wreck
