Mystery wreck may be Lt. Bishop's lost P-40 that was shot down December 7th, 1941

By Dave Trojan, Aviation Historian, davidtrojan@earthlink.net

Dec 2014

Crash site Investigation and historical significance

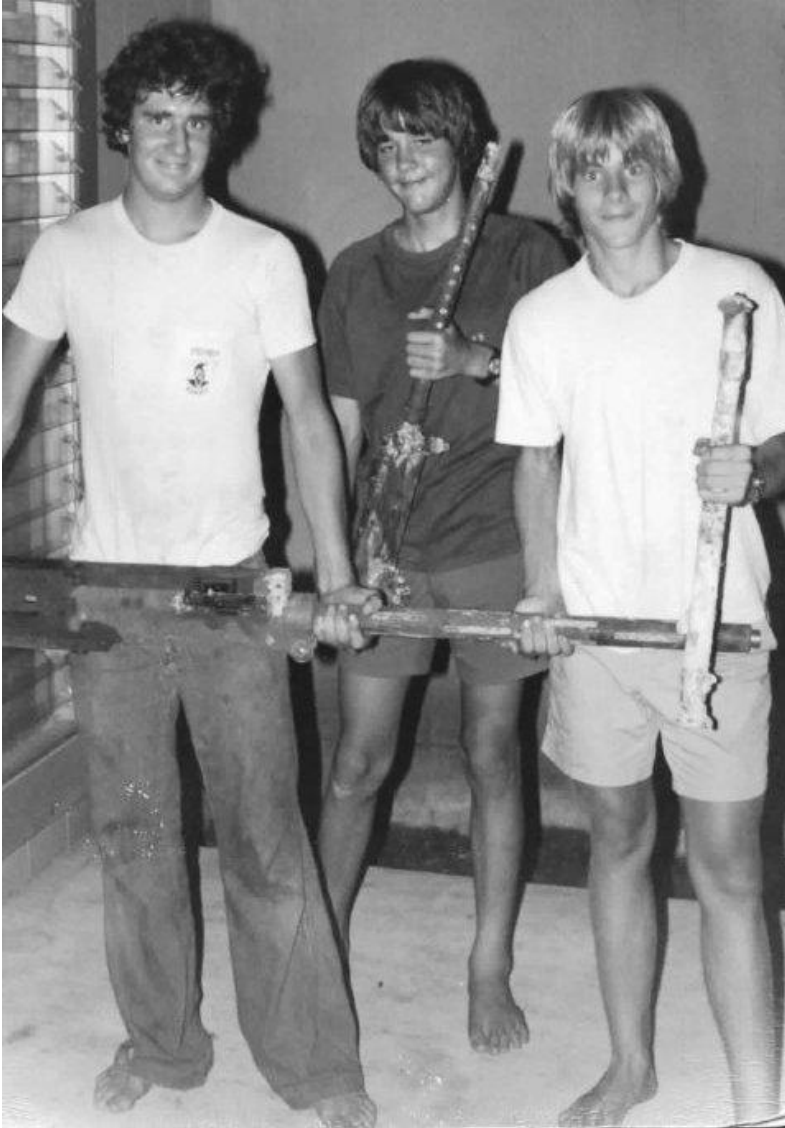
Three proud young boys showing off their treasure

Artifacts recovered by the trio included: carburetor temperature gauge, control stick, eight day clock, part of the artificial horizon indicator, radio equipment, machine guns and some ammunition. An inventory of some of the items and their identity marks was later made by one of the boy's father.
